Water Quality Monitoring Report April 2022

Newcastle Cruising Yacht Club

File No 0-950 Water Quality Monitoring

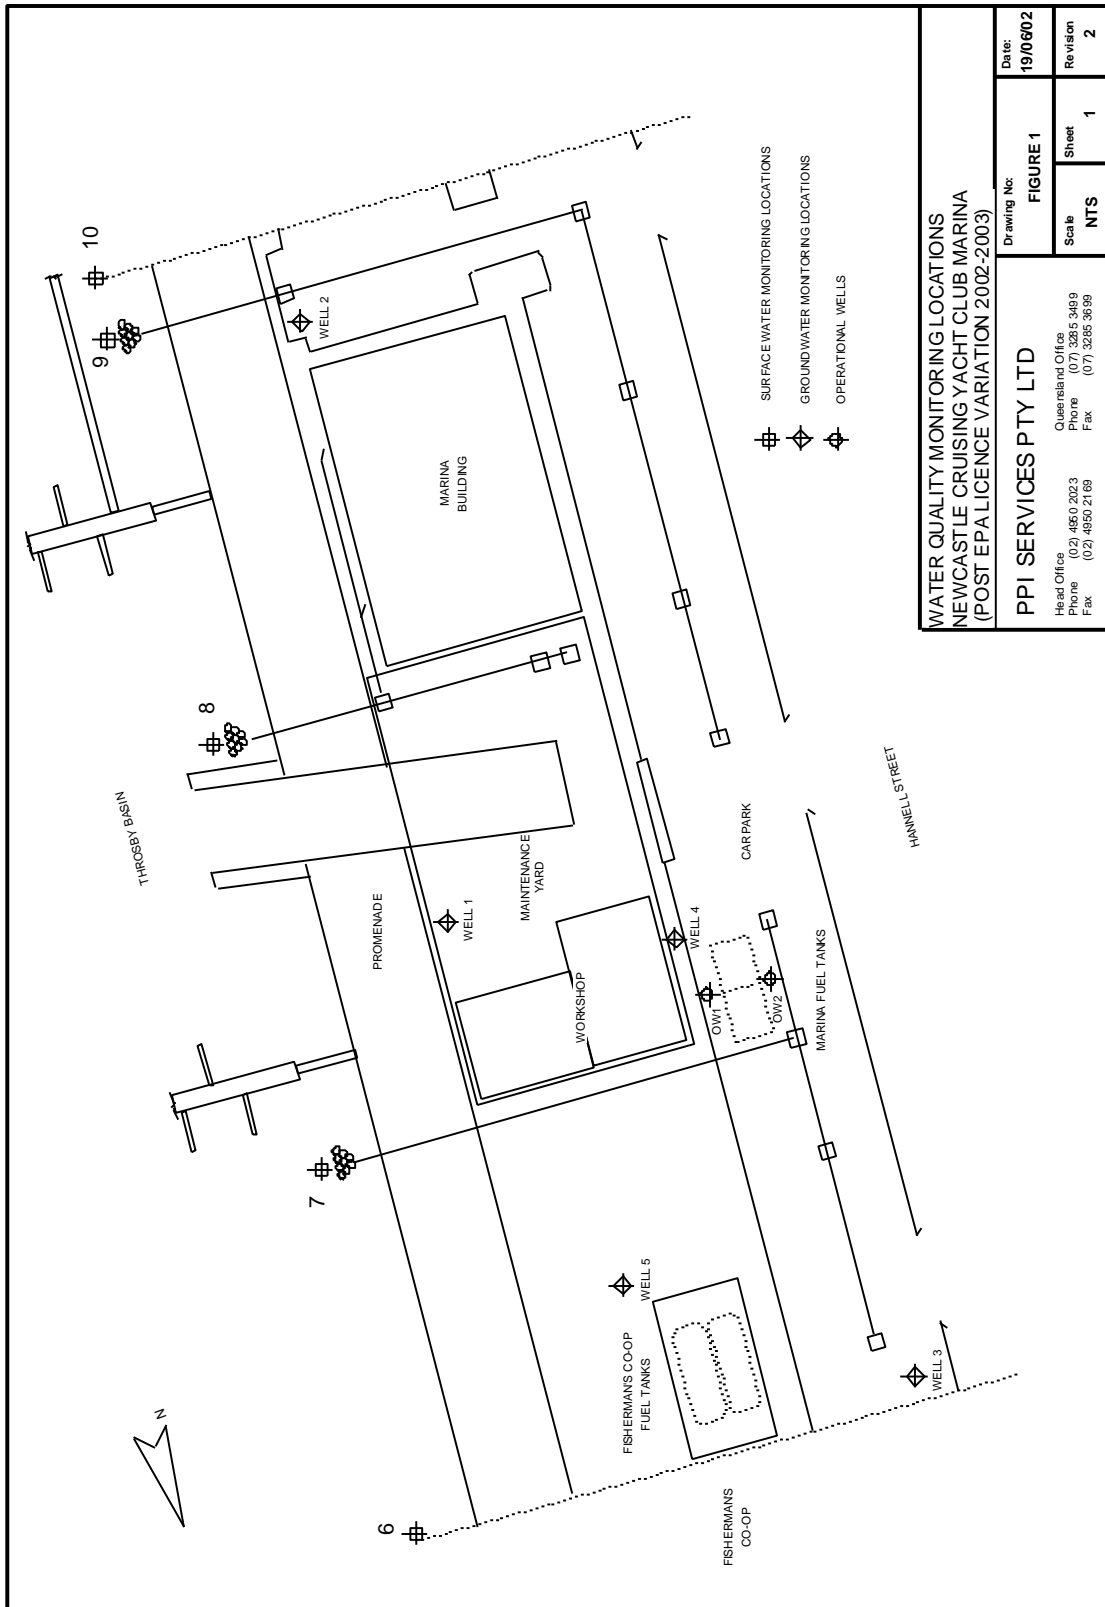
Sample Locations as Per **Figure 1**

GW1: Water at 1.93metres and well bottom at 4.16 metres
pH 7.3
Temperature 23.6°C
No hydrocarbon detected by interface probe
No visible hydrocarbon observed
No olfactory evidence of hydrocarbon

GW4: Water at 2.34 metres and well bottom at 3.40 metres
pH 7.1
Temperature 22.1°C
No hydrocarbon detected by interface probe
No visible hydrocarbon observed
No olfactory evidence of hydrocarbon
