Water Quality Monitoring Report April 16

Newcastle Cruising Yacht Club

File No 0-950 Water Quality Monitoring

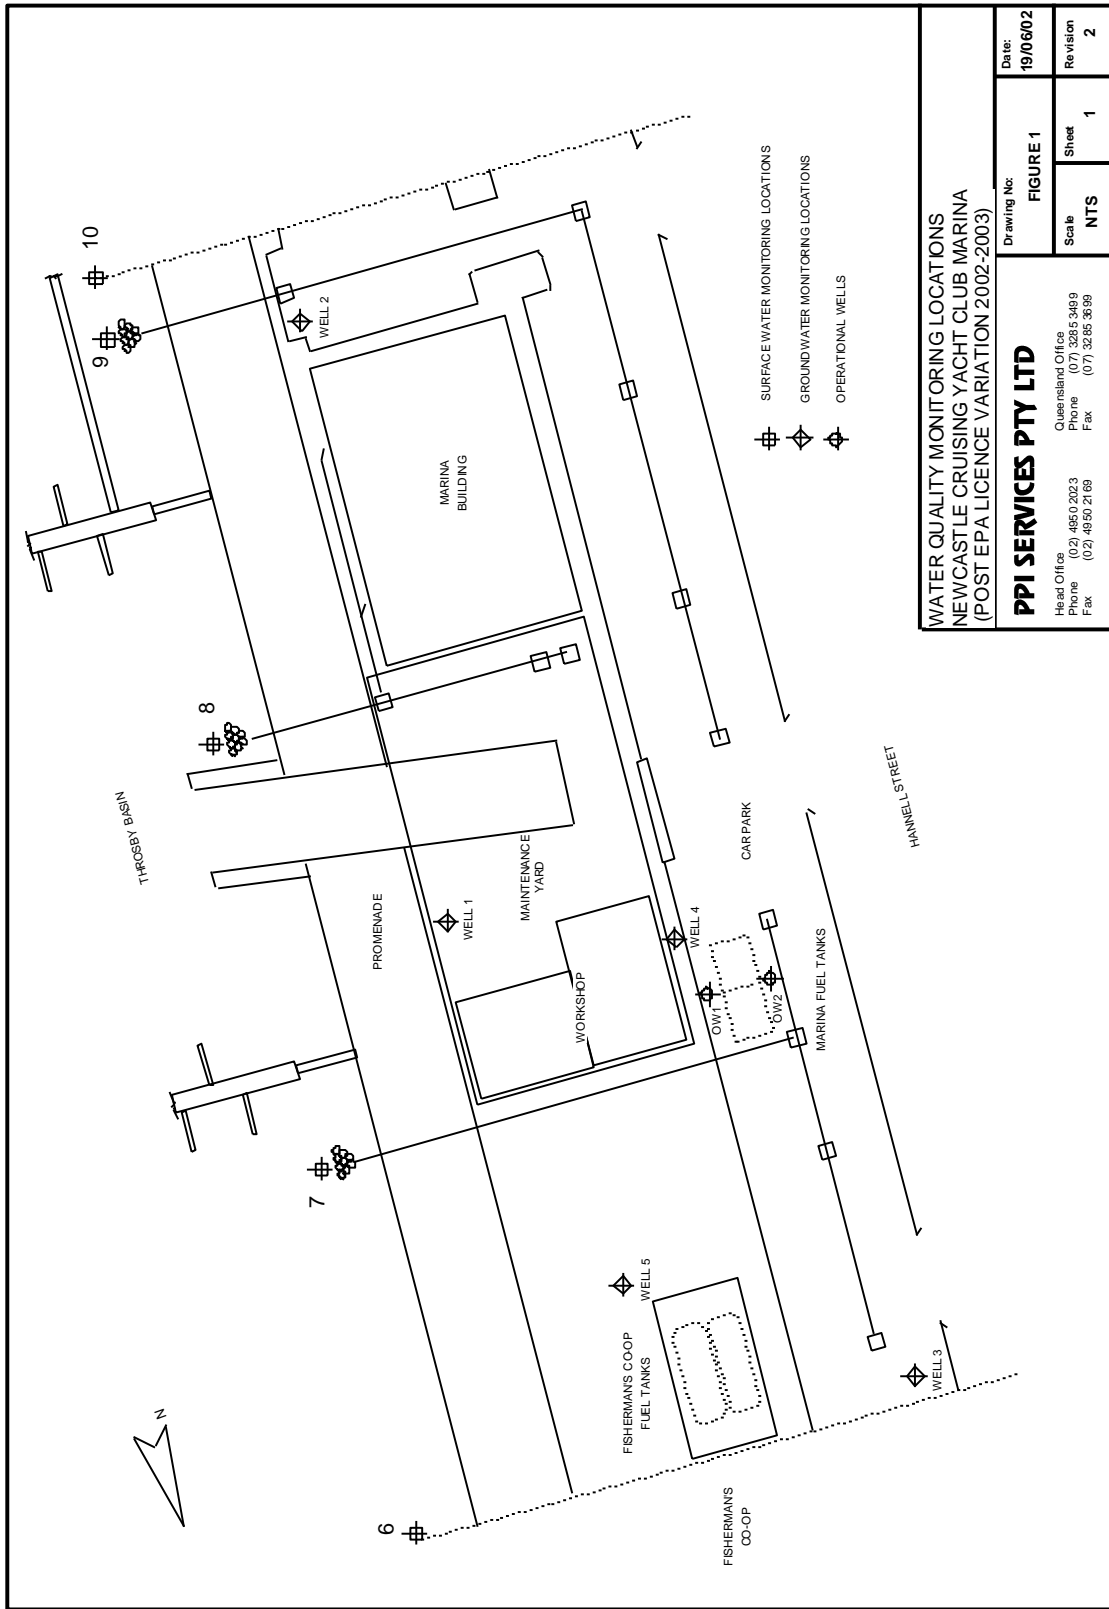
GW1: Water at 2.19 metres and well bottom at 4.16 metres
pH 7.76 and temperature 24.5°C
No hydrocarbon detected by interface probe
No visible hydrocarbon observed
No olfactory evidence of hydrocarbon

GW4: Water at 2.50 metres and well bottom at 3.32 metres
pH 7.0 and temperature 24.2°C
No hydrocarbon detected by interface probe
No visible hydrocarbon observed
No olfactory evidence of hydrocarbon
