# Water Quality Monitoring Report October 2022

Newcastle Cruising Yacht Club

File No 0-950 Water Quality Monitoring

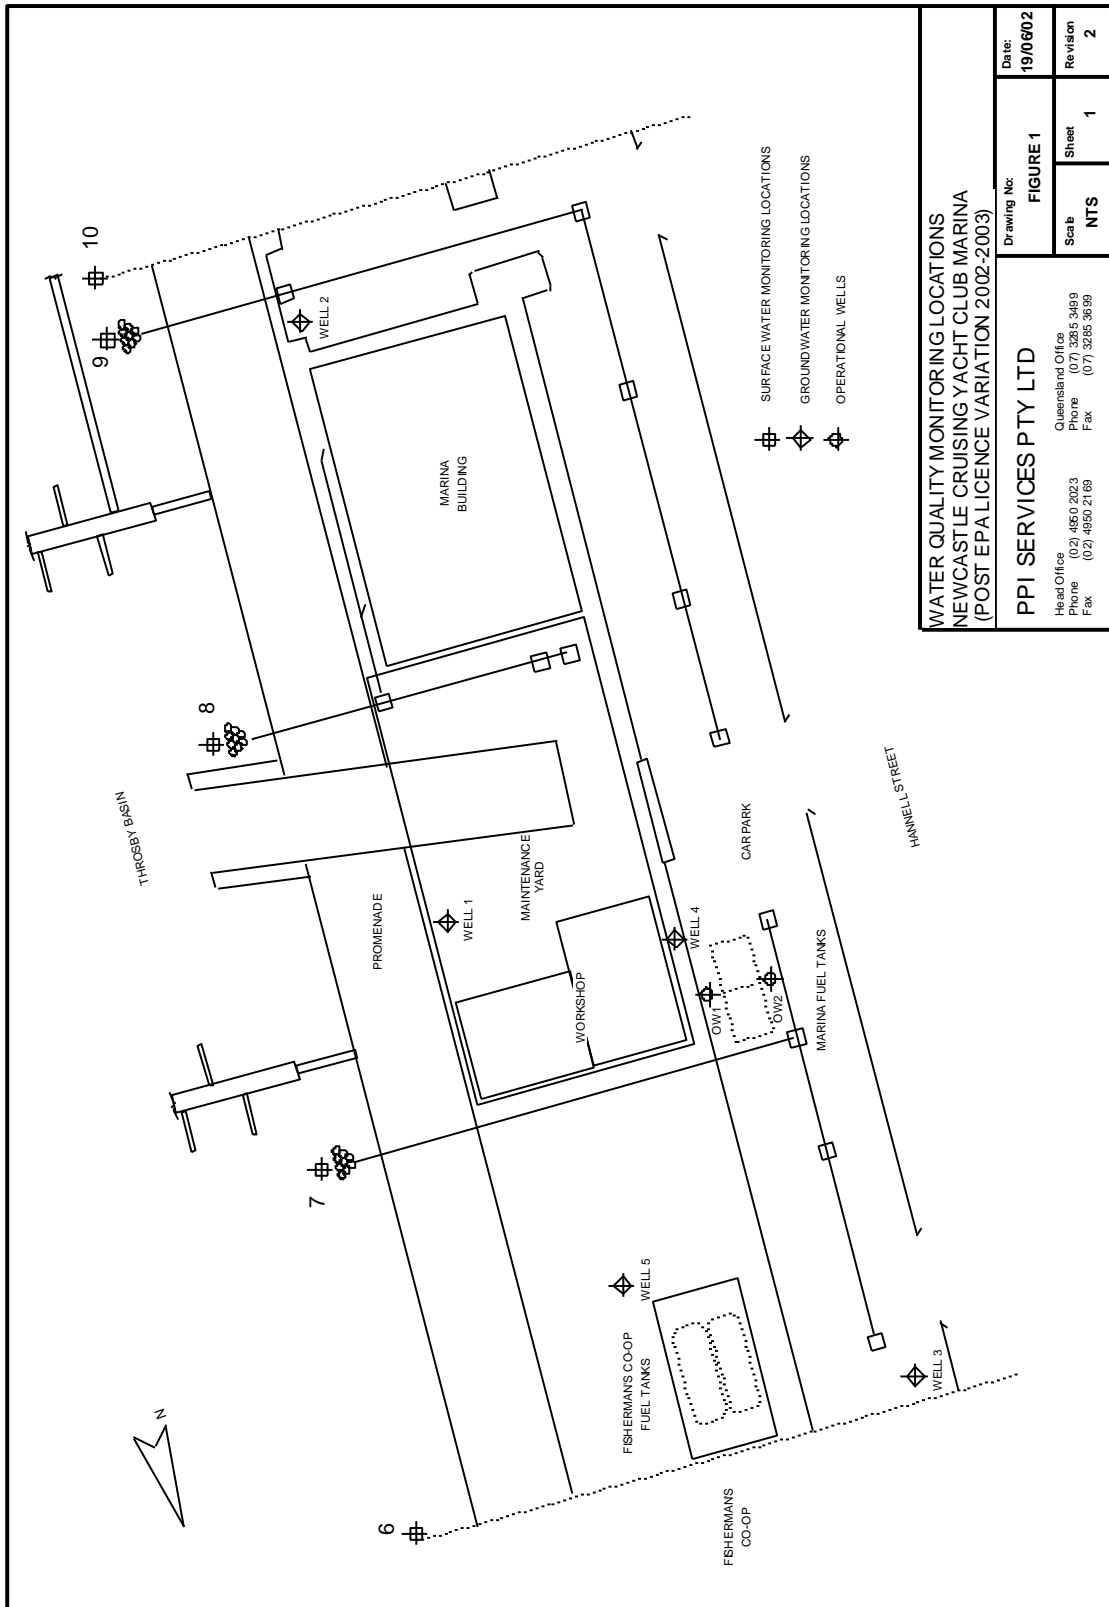
Sample Locations as Per **Figure 1**

GW1: Water at 1.95 metres and well bottom at 4.15 metres  
pH 6.9  
Temperature 22.5°C  
No hydrocarbon detected by interface probe  
No visible hydrocarbon observed  
No olfactory evidence of hydrocarbon

GW4: Water at 2.37 metres and well bottom at 3.40 metres  
pH 7.0  
Temperature 21.7°C  
No hydrocarbon detected by interface probe  
No visible hydrocarbon observed  
No olfactory evidence of hydrocarbon
