Water Quality Monitoring Report April 17

Newcastle Cruising Yacht Club

File No 0-950 Water Quality Monitoring

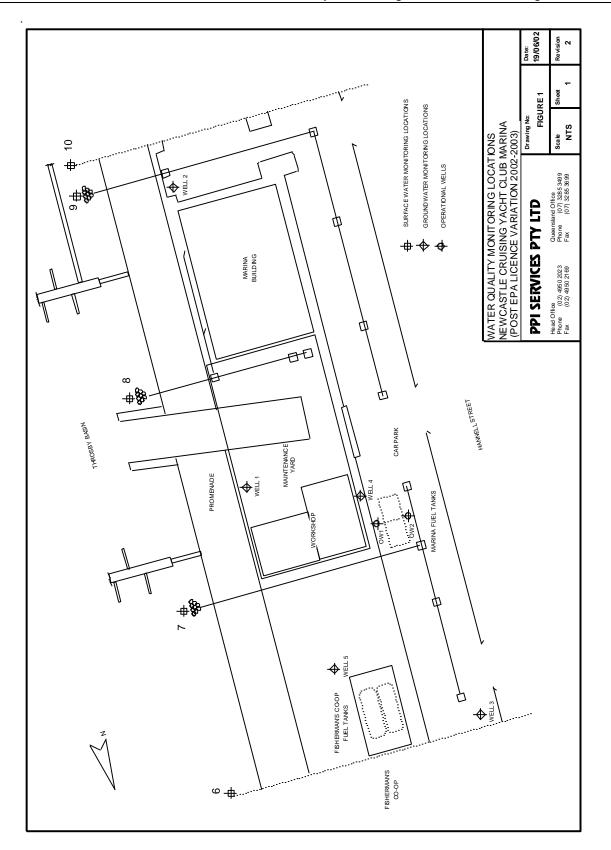
Sample Locations as Per Figure 1

GW1: Water at 2.23 metres and well bottom at 4.13 metres pH 7.1 Temperature 23.2°C No hydrocarbon detected by interface probe No visible hydrocarbon observed No olfactory evidence of hydrocarbon GW4: Water at 2.32 metres and well bottom at 3.35 metres pH 7.4 Temperature 22.9°C No hydrocarbon detected by interface probe No visible hydrocarbon observed No olfactory evidence of hydrocarbon

No hydrocarbons were detected in the wells sampled or in the underground storage tanks interstitial space.
