# Water Quality Monitoring Report October 2023

Newcastle Cruising Yacht Club

File No 0-950 Water Quality Monitoring

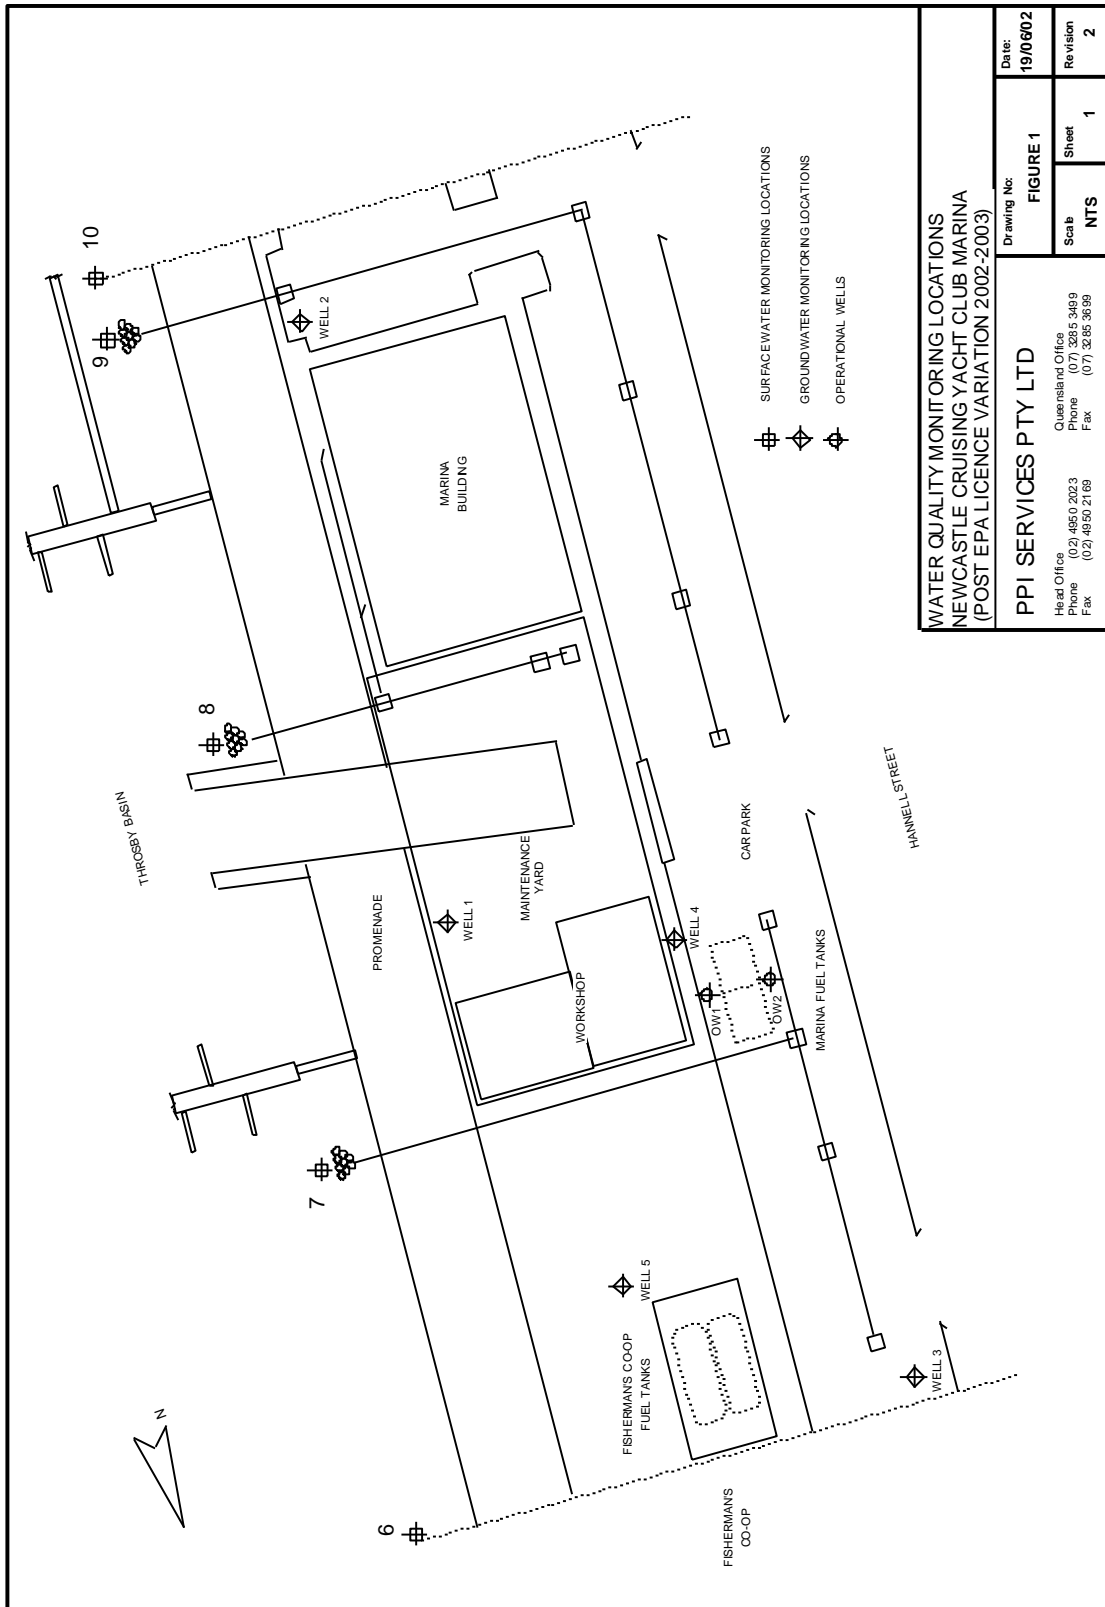
Sample Locations as Per **Figure 1**

GW1: Water at 2.41 metres and well bottom at 4.16 metres  
pH 6.9  
Temperature 19.0°C  
No hydrocarbon detected by interface probe  
No visible hydrocarbon observed  
No olfactory evidence of hydrocarbon

GW4: Water at 2.62 metres and well bottom at 3.38 metres  
pH 7.0  
Temperature 19.5°C  
No hydrocarbon detected by interface probe  
No visible hydrocarbon observed  
No olfactory evidence of hydrocarbon
