Water Quality Monitoring Report April 15

Newcastle Cruising Yacht Club

File No 0-950 Water Quality Monitoring

By **PPI Services Pty. Limited**
ABN 47 003 693 123

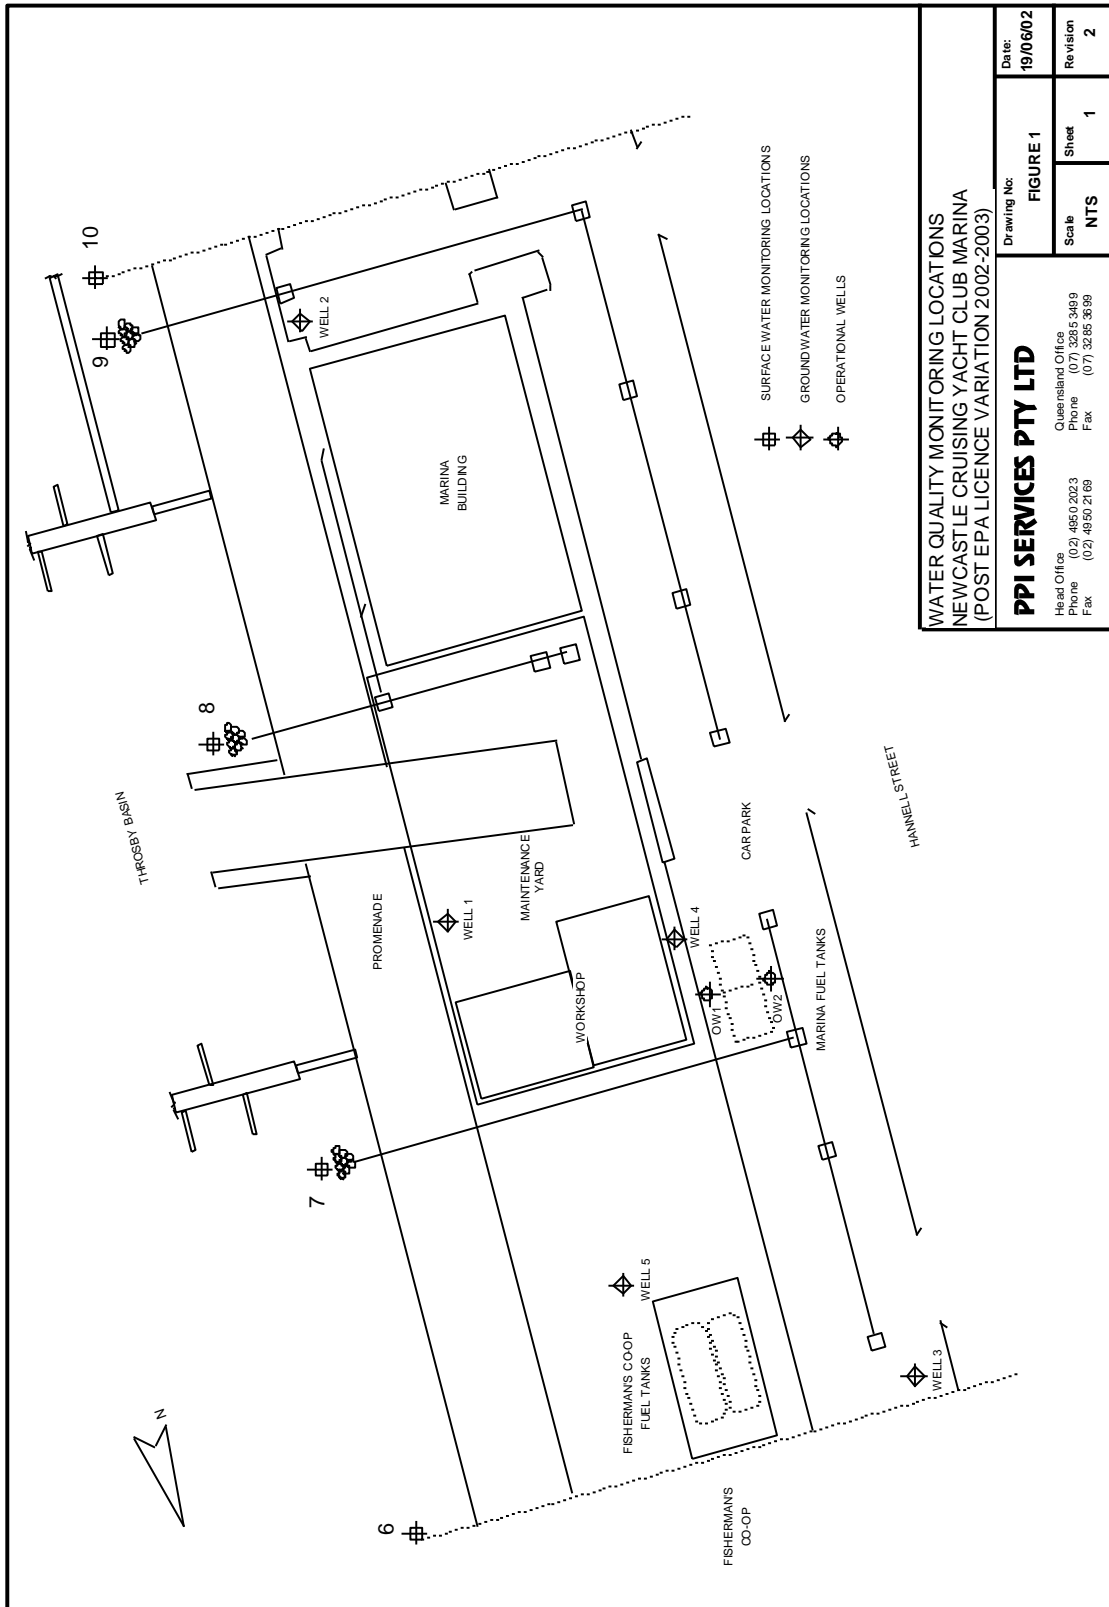
Sample Locations as Per **Figure 1**

GW1: Water at 2.02 metres and well bottom at 4.14 metres

No hydrocarbon detected by interface probe and no visible hydrocarbon observed

GW4: Water at 2.30 metres and well bottom at 3.28 metres
pH 7.0 and temperature 18.0°C

The levels in GW1 were comparable to previous recordings. The well bottom in GW4 has been reduced compared to previous recordings. This reduction in well depth coincides with the disturbance of the surrounding soil when the old UPSS tank was removed. The changes in depth in GW4 will continue to be documented in future reports.
