Water Quality Monitoring Report April 2026

Newcastle Cruising Yacht Club

File No 0-950 Water Quality Monitoring

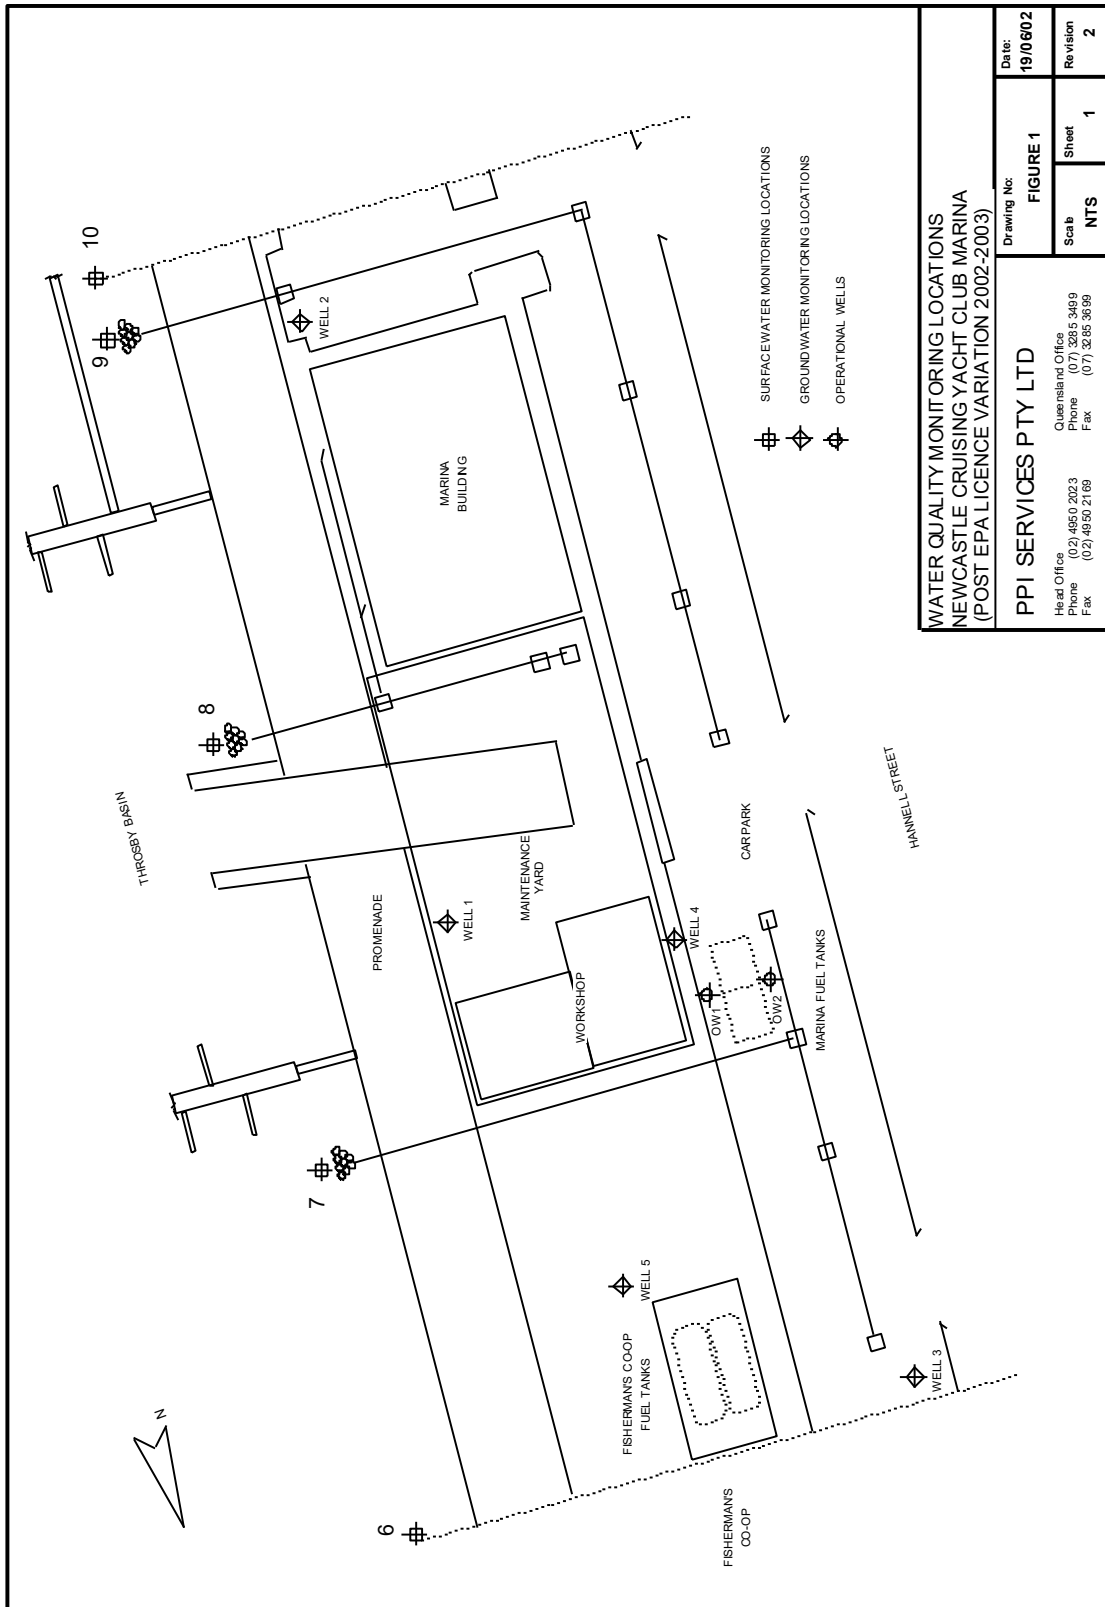
Sample Locations as Per **Figure 1**

GW1: Water at 2.34 metres and well bottom at 4.16 metres
pH 6.9
Temperature 23.9°C
No hydrocarbon detected by interface probe
No visible hydrocarbon observed
No olfactory evidence of hydrocarbon

GW4: Water at 2.36 metres and well bottom at 3.34 metres
pH 6.6
Temperature 23.0°C
No hydrocarbon detected by interface probe
No visible hydrocarbon observed
No olfactory evidence of hydrocarbon
