Water Quality Monitoring Report October 2025

Newcastle Cruising Yacht Club

File No 0-950 Water Quality Monitoring

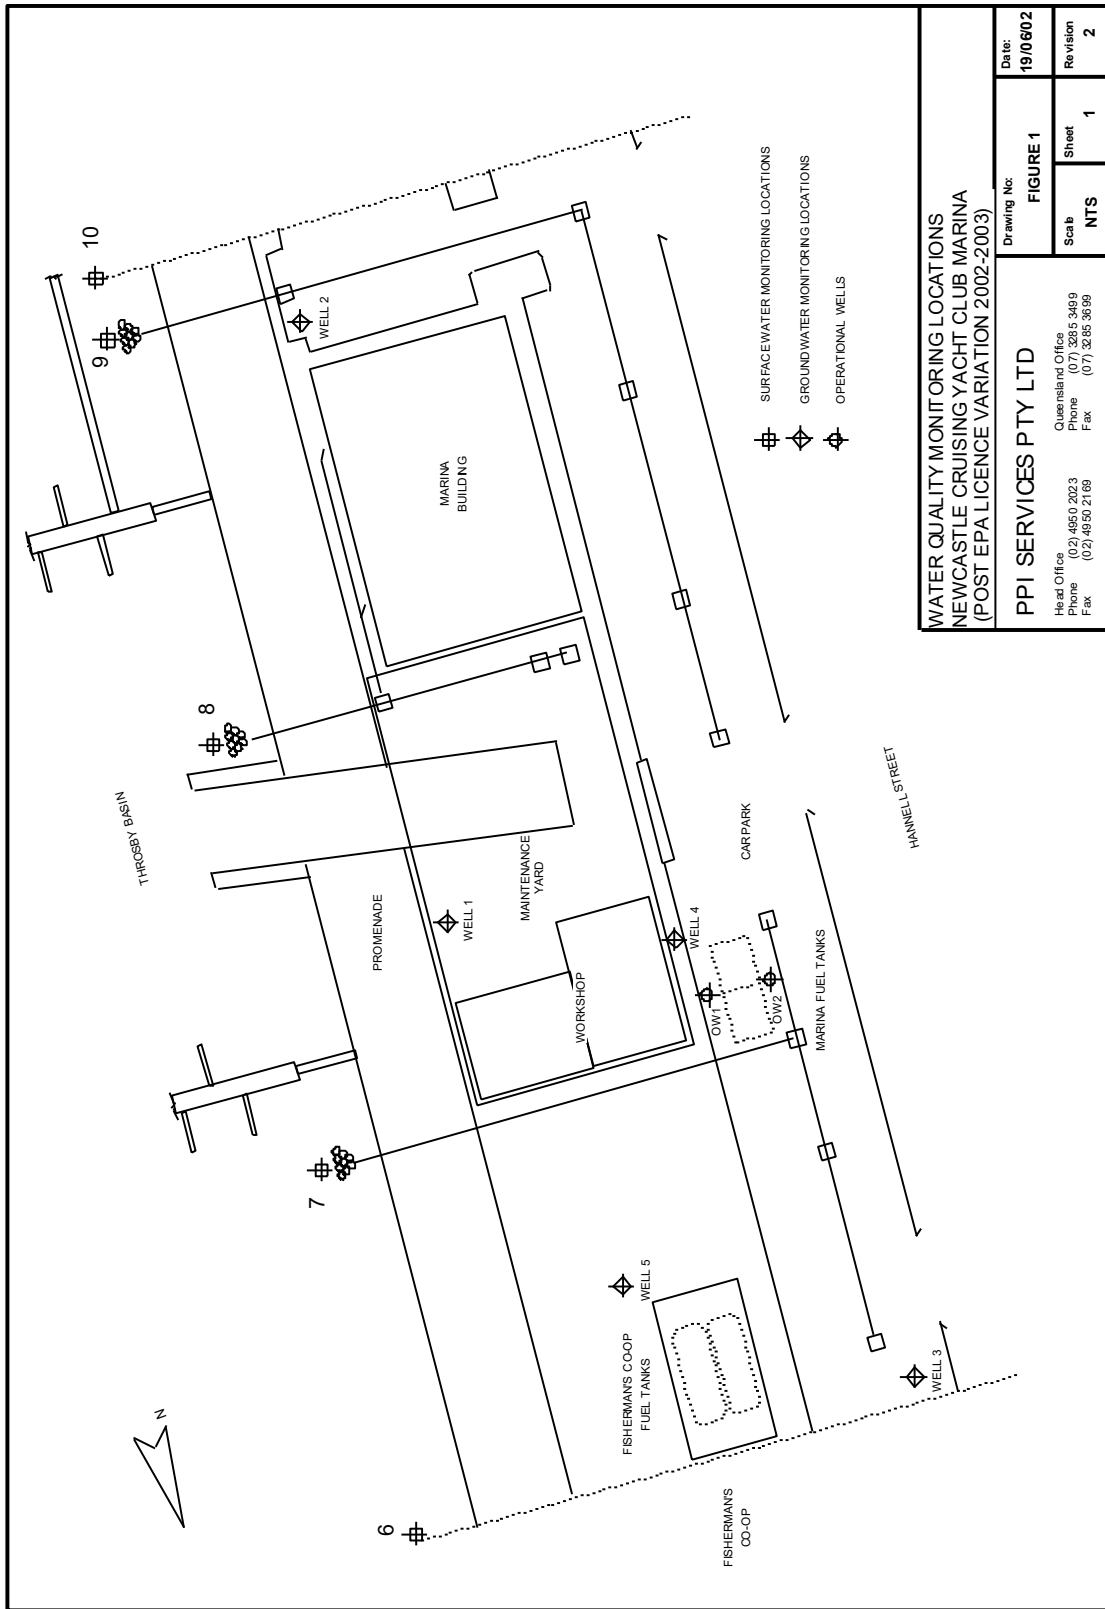
| Drawing No: | FIGURE 1 |

Sample Locations as Per **Figure 1**

WATER QUALITY MONITORING LOCATIONS
NEWCASTLE CRUISING YACHT CLUB MARINA
 (POST EPA LICENCE VARIATION 2002-2003)
