Water Quality Monitoring Report November 2012

Newcastle Cruising Yacht Club

File No 0-950 Water Quality Monitoring

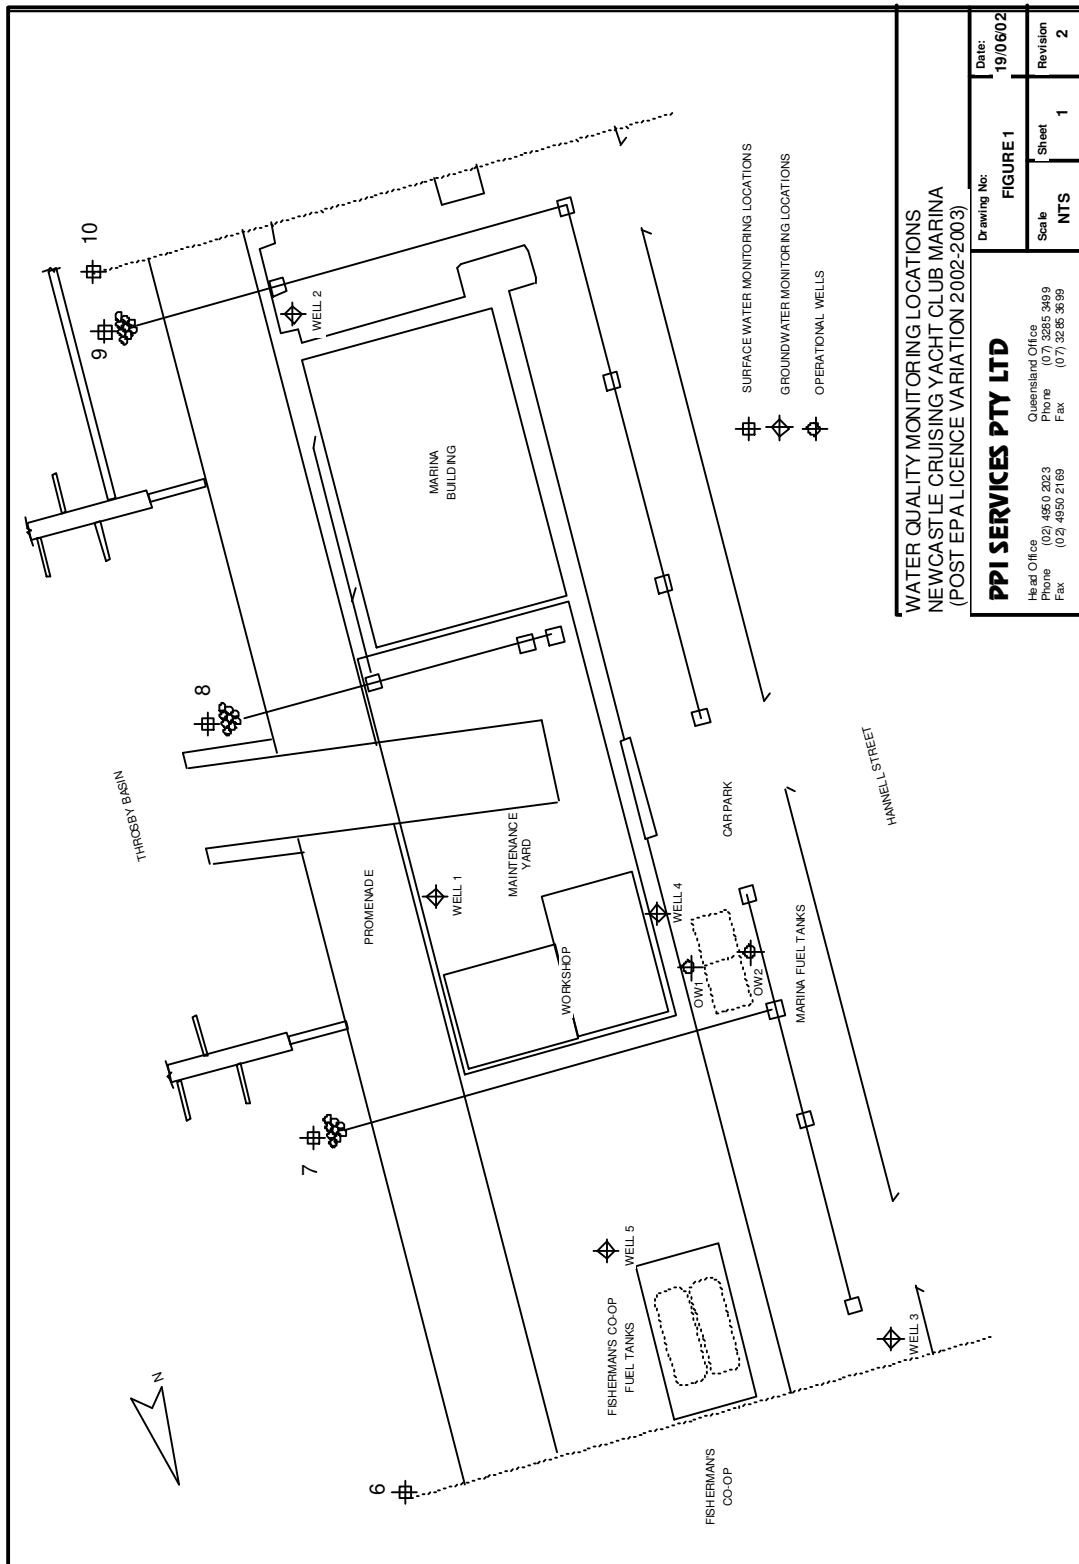
Sample Locations as Per **Figure 1**

GW1: Water at 2.26 metres and well bottom at 4.20 metres
pH 7.0
No hydrocarbon detected by interface probe and no visible hydrocarbon observed

GW2: Water at 2.43 metres and well bottom at 4.50 metres
pH 6.1
No hydrocarbon detected by interface probe and no visible hydrocarbon observed

GW4: Water at 2.80 metres and well bottom at 4.80 metres
pH 6.1
No hydrocarbon detected by interface probe and no visible hydrocarbon observed
